# COMPARISON OF CORROSION BEHAVIOUR OF COMMERCIAL ALUMINIUM ENGINE BLOCK AND PISTON IN 3.5% NaCl SOLUTION

## **ABSTRACT**

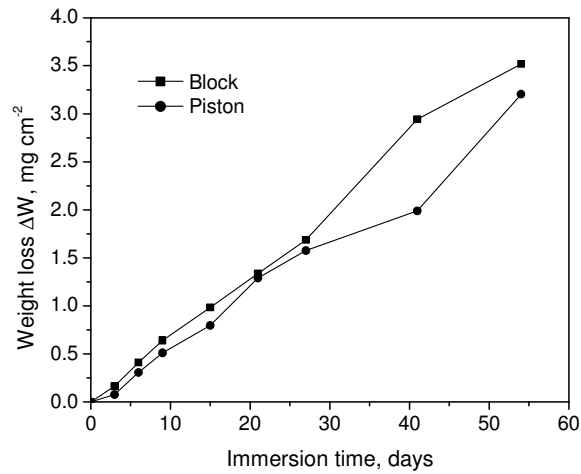
Figure 1. The variation of the weight loss ( $\text{mg/cm}^2$ ) as a function of immersion time (days) for aluminium alloy engine block and piston immersed in 3.5% NaCl solution.

Figure 1 depicts the change of weight loss  $\Delta W$ ,  $\text{mg cm}^{-2}$ , calculated using Eq. (1) as a function of immersion time for aluminium alloy engine block and piston immersed in 3.5% NaCl solution. It is clearly seen from Figure 1 that the value of  $\Delta W$  for the alloy in  $\text{Cl}^-$  solutions increased with increasing immersion time. This is due to the continuous dissolution under the aggressive action

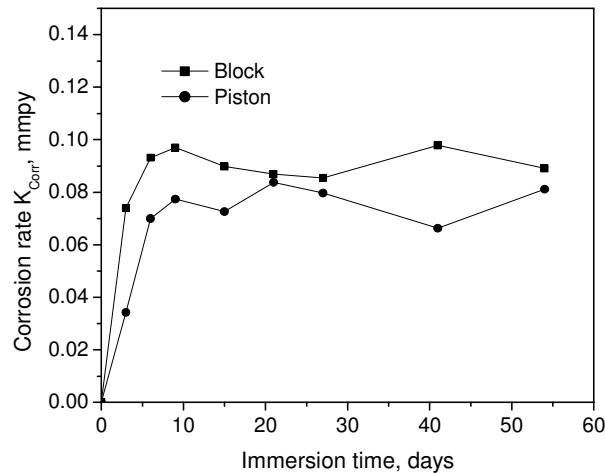
Figure 2. The change of corrosion rate (mmpy) as a function of immersion time (days) for aluminium alloy engine block and piston immersed in 3.5% NaCl solution

of the chloride ions to the alloy surface. Although Al forms  $\text{Al}_2\text{O}_3$  and  $\text{Al}(\text{OH})_2$  on its surface, its dissolution rapidly increases with increasing exposure time. This is due to the fact that these forms are not compact and not protective and allow the aggressive ions from NaCl solutions to attack the Al surface. The values of  $K_{\text{Corr}}$ , which were calculated from weight-loss tests using Eq. (2) for Al alloy in 3.5% NaCl solutions, are plotted against time as shown in Figure 2. It can be seen that, the  $K_{\text{Corr}}$  values increased quite abruptly initially until immersion time of 10 days. Afterwards, the  $K_{\text{Corr}}$  value decreased with time and attained roughly a constant value. This is due to the fact that it corrodes (reacts with oxygen molecules) very quickly. Aluminum forms a very thin film of aluminum oxide and hydroxide which is about 2 nm (nanometer or  $10^{-9}$ ) thick. And it has a very strong bond to its surface and, if damaged or scratched, reforms immediately in most environments. The cathode reaction of dissolved oxygen and formation of  $\text{OH}^-$  ions occurs on  $\text{Al}_3\text{Fe}$  particles. These ions react chemically with a protective  $\text{Al}_2\text{O}_3$  film. The Ni-containing amorphous alloy showed a pitting potential greater than the Ni-free amorphous alloy. Comparing the amorphous alloys, the addition of Ni enhances the pitting potential to a greater extent even though both alloys are amorphous. The effect is pronounced even following devitrification. Although a significant decreases in pitting potential was observed by devitrification of both alloys. The aluminium piston alloy showed a mean pitting potential greater than aluminium engine block [7].

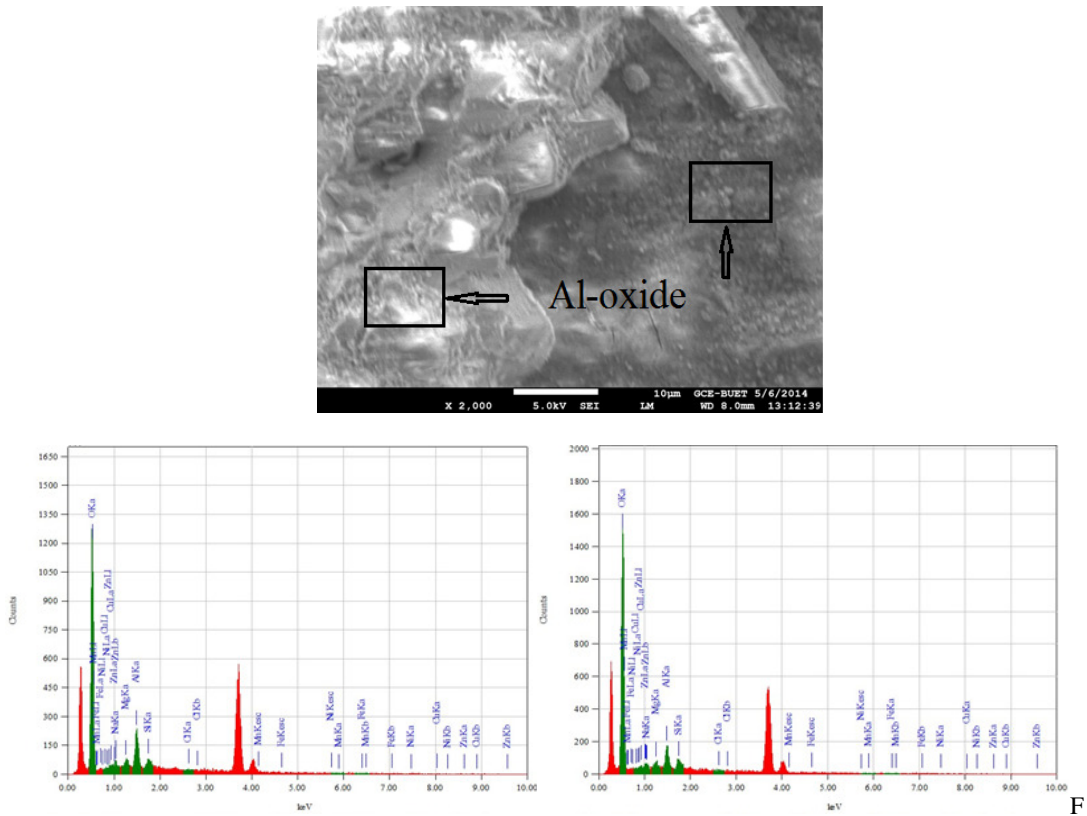
Figure 6. SEM images and EDX spectra obtained for samples of aluminium alloy Engine block after exposure in a 3.5% NaCl solution for 54 days

The SEM image in the aluminium engine block of the surface after 54 days of prolonged exposure in 3.5% NaCl solution as shown in Figure 6, which indicates that the surface composes of two regions. One is covered with grass like corrosion products from which the mushrooms were formed and the other area is covered with a thin layer of corrosion products. The corresponding EDX profile analyses for the selected square areas of the SEM are shown in Figure 6. The weight percentage of elements found in white area were 81.60% O, .81% Na, 1.78% Mg, 11.03% Al, 2.33% Si, 0.23% Cl, 0.10% Mn, 0.79% Cu, 1.34% Zn and in dark area were 85.54% O, 1.60% Na, 1.52% Mg, 6.82% Al, 2.81% Si, 0.16% Cl, 0.58% Mn, 0.61% Cu, 0.37% Zn.

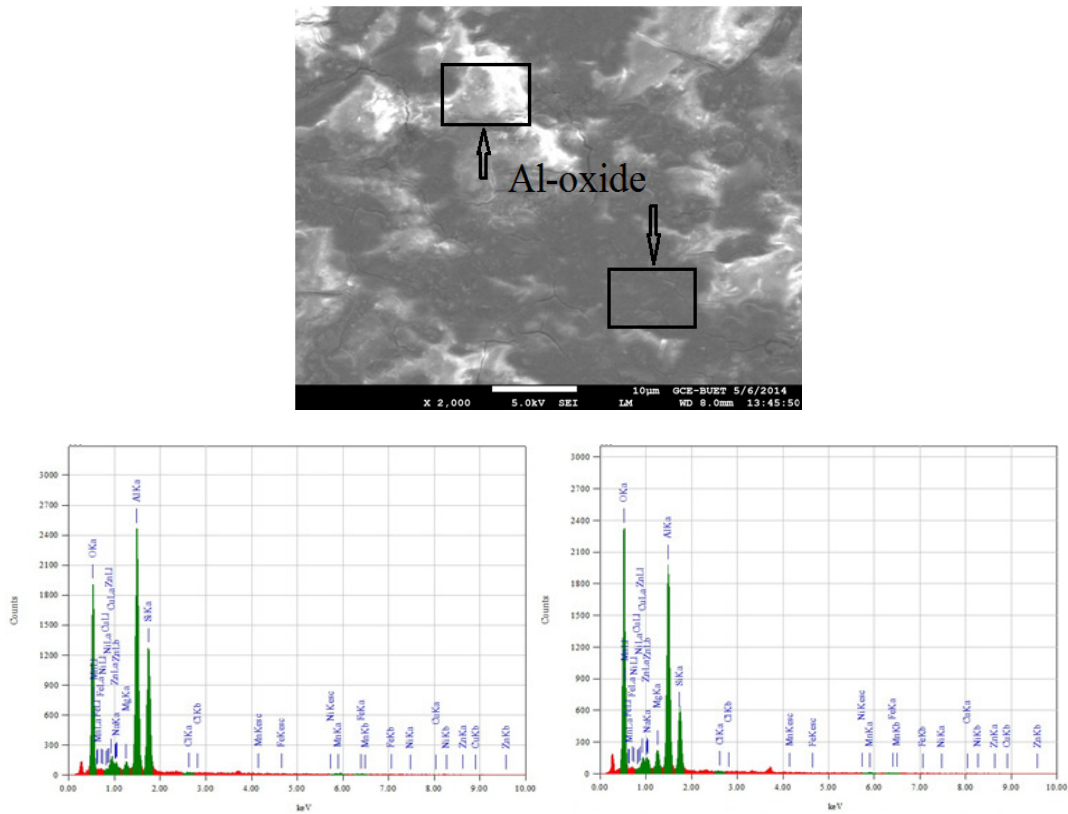
Figure 7. SEM images and EDX spectra obtained for samples of aluminium alloy piston after exposure in a 3.5% NaCl solution for 54 days

Similarly, the SEM image in the aluminium piston of the surface after 54 days of prolonged exposure in 3.5% NaCl solution as shown in Figure 7, which indicates that the surface composes corrosion products similar to that of engine block where the corrosion product is uniformly distributed. The corresponding EDX profile analyses for the selected square areas of the SEM are shown in Figure 7. The weight percentage of elements found in white area were 42.35% O, 0.45% Na, 0.77% Mg, 29.84% Al, 20.57% Si, 0.20% Cl, 1.62% Mn, 1.57% Fe, 0.47% Ni, 1.60% Cu, 0.56% Zn and in dark area were 51.55% O, 0.83% Na, 2.50% Mg, 27.84% Al, 11.45% Si, 0.03% Cl, 2.16% Mn, 1.12% Fe, 1.39% Cu, 1.13% Zn. After 54 days of prolonged exposure in 3.5% NaCl solution, it can be observed that the sample has been descaled as a consequence of fracturing of the surface film. The surface oxide film was observed to develop at an early period and increased in area and in thickness with the passage of time [6].
